## Intervention Engineering

# Inspection of Ten West 1 and Oliver 2 wells

PTTEP / Petrofac

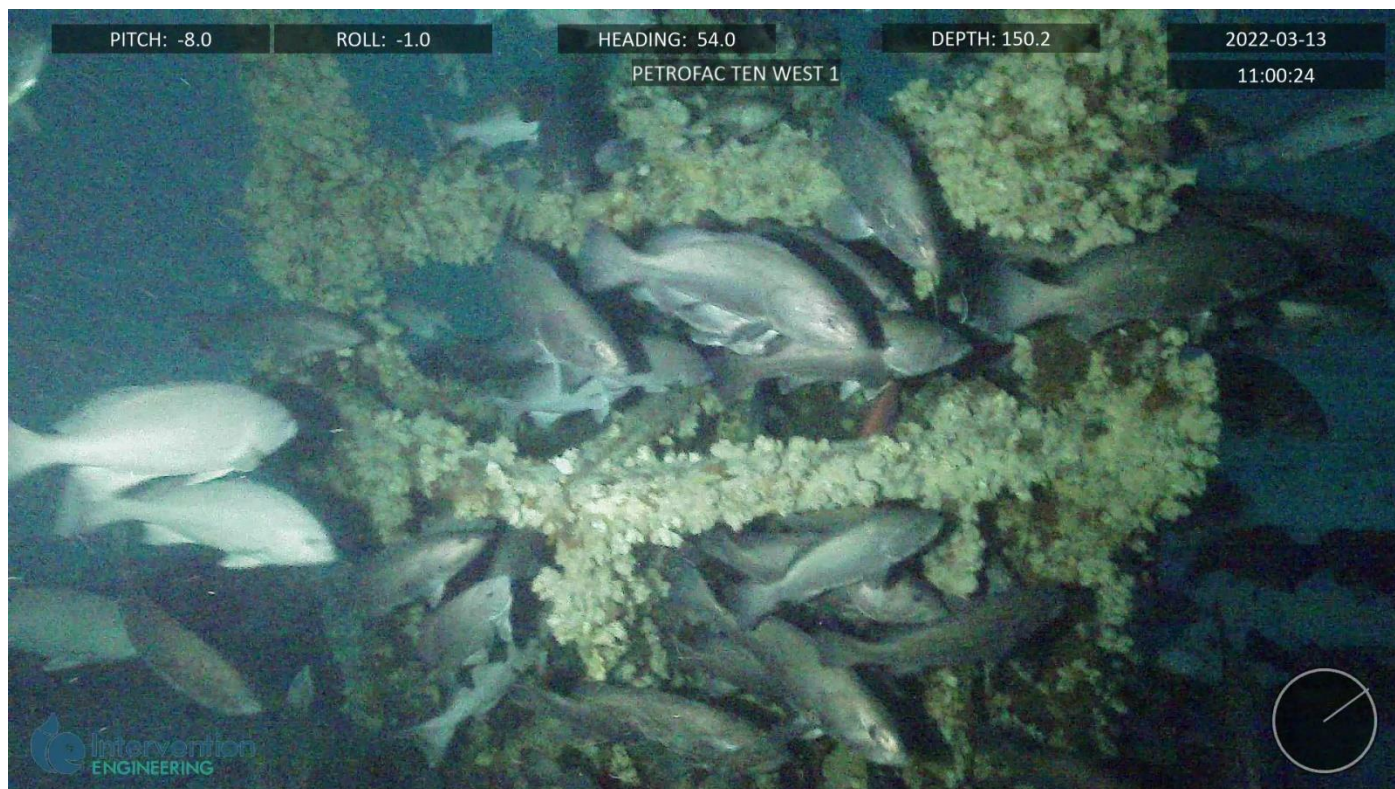
The wellhead had significant hard marine growth and appeared to be a haven for fish and other marine life in the area. (Figure 2)

**Figure 2** Ten West 1 well marine life overview

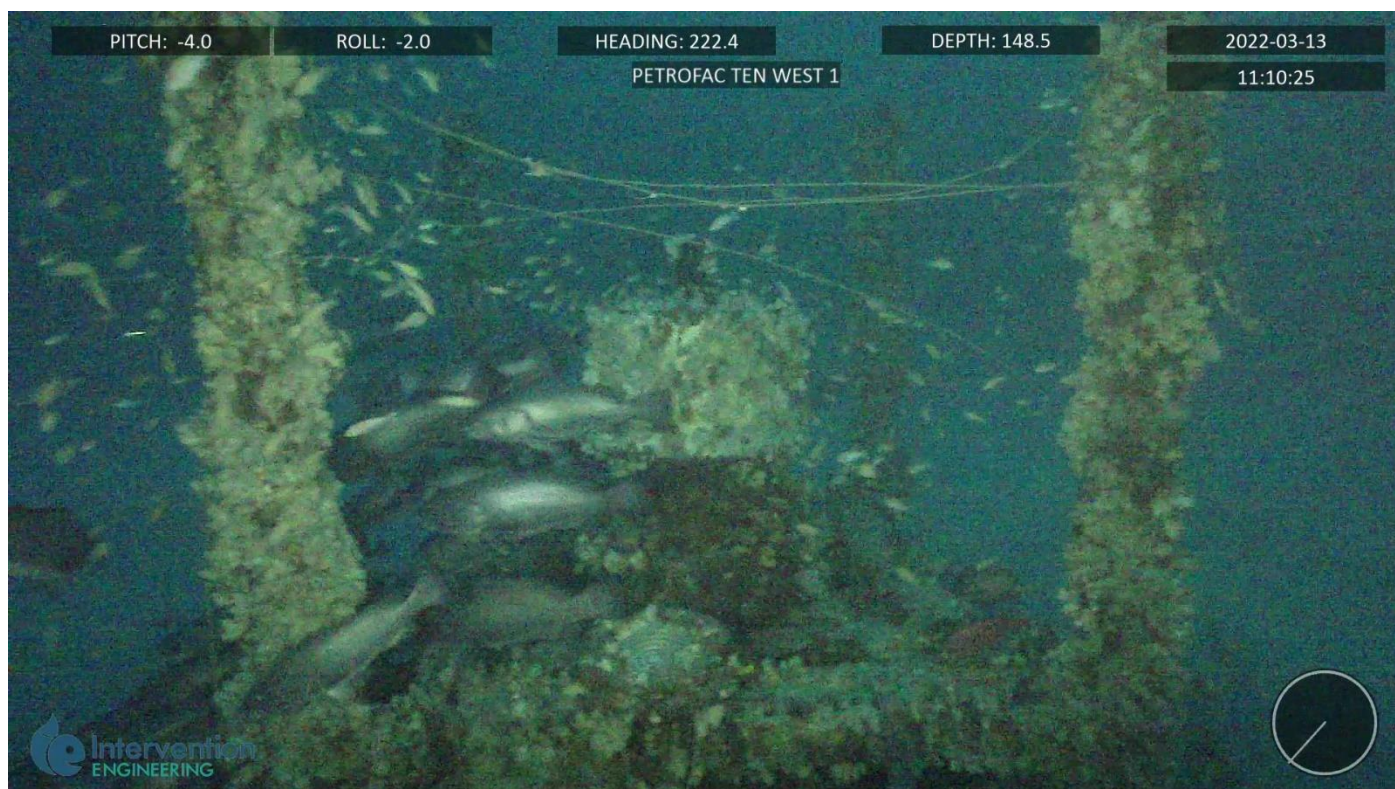
There was some minor fishing gear entanglement on the wellhead consisting of mostly fishing line. There was no fishing net seen on the wellhead. (Figure 3)

**Figure 3** Ten West 1 fishing line entanglement

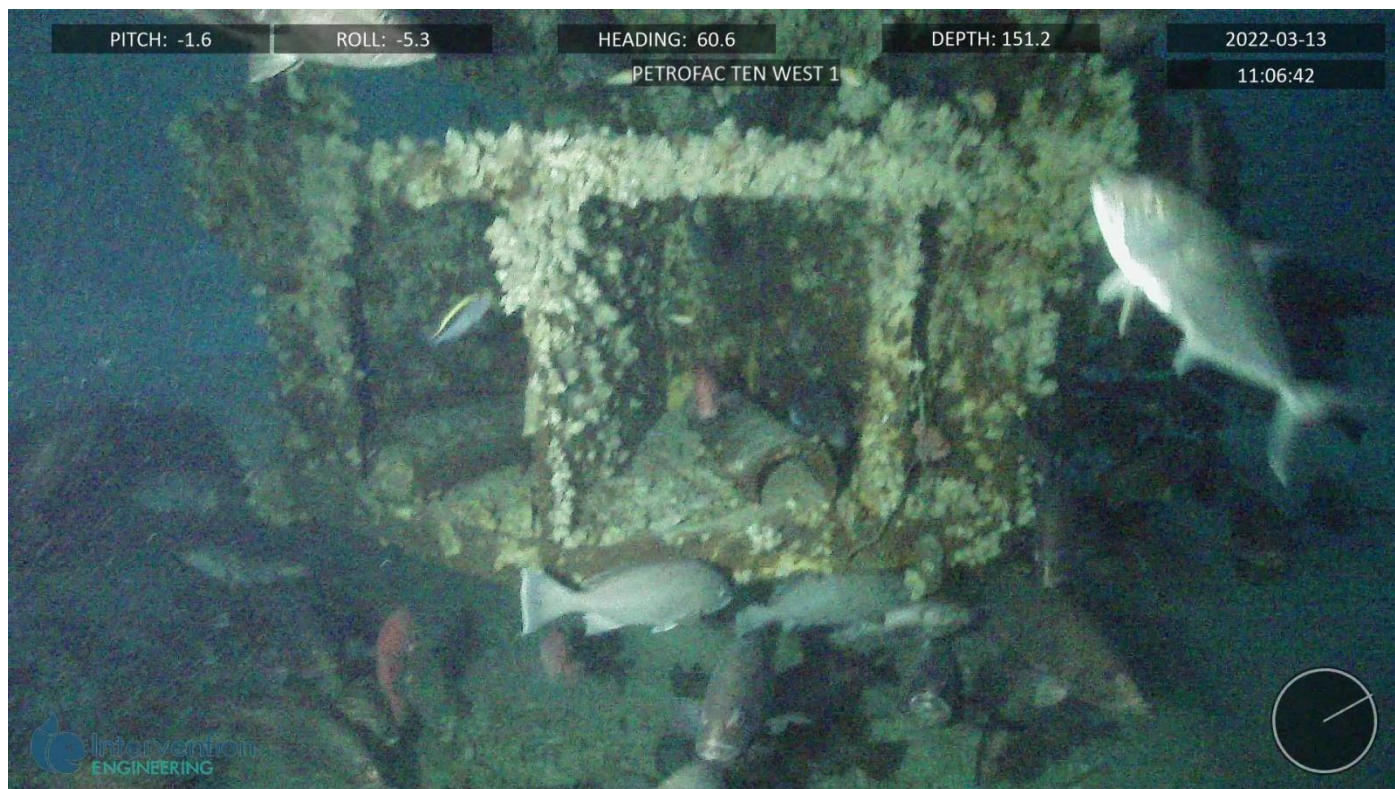
The wellhead had evident corrosion in all main areas, with the TGB appearing the most heavily corroded (Figure 4). There were no anodes seen on the wellhead or guide bases during the survey.

**Figure 4** Ten West 1 example of corrosion

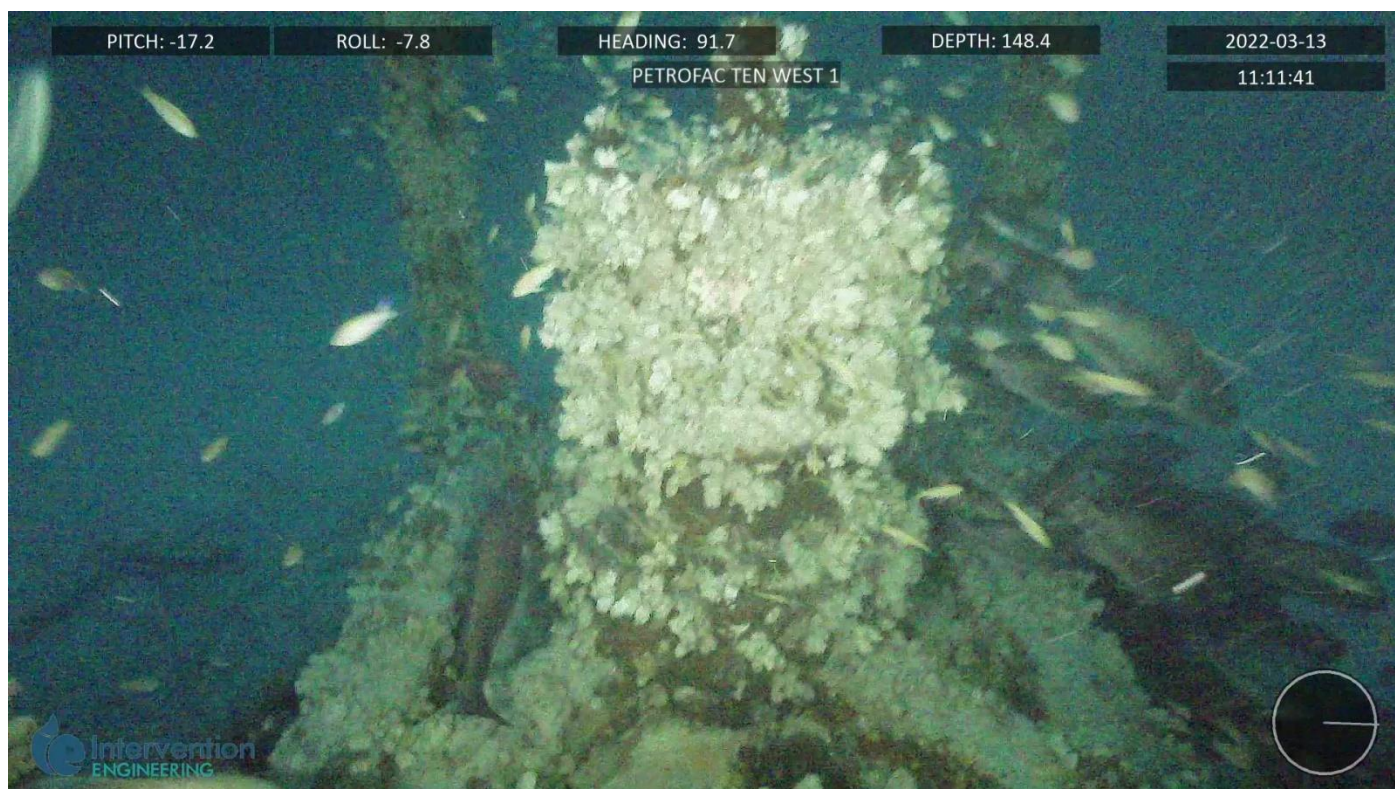
The corrosion cap appeared intact, in place and appeared undamaged. (Figure 5)

**Figure 5** Ten West 1 corrosion cap

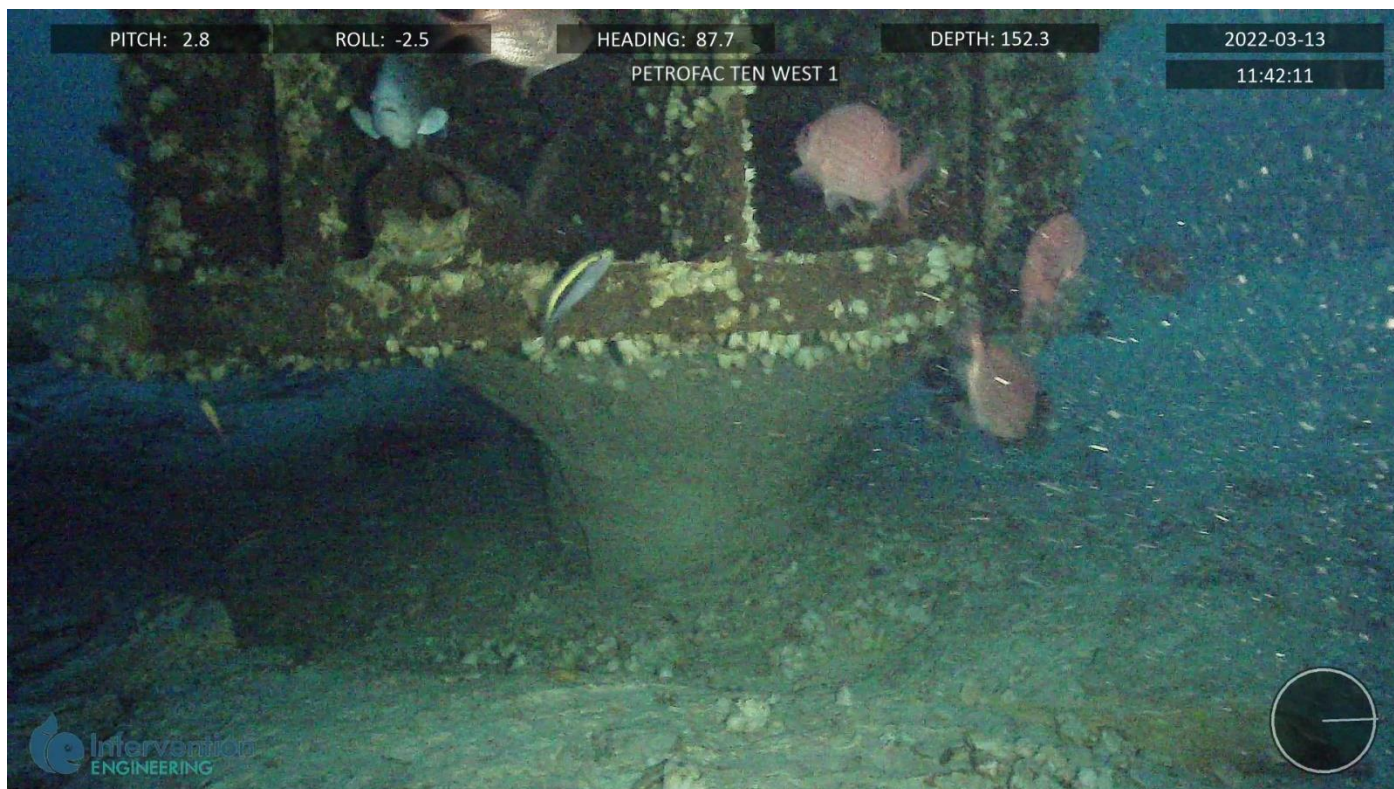
There was some scouring occurring under the wellhead, approx. 0.3m to 0.4m under the TGB. This lowest point was measured at 1m below mean seabed. (Figure 6)

**Figure 6** Ten West 1 example scour under guide base

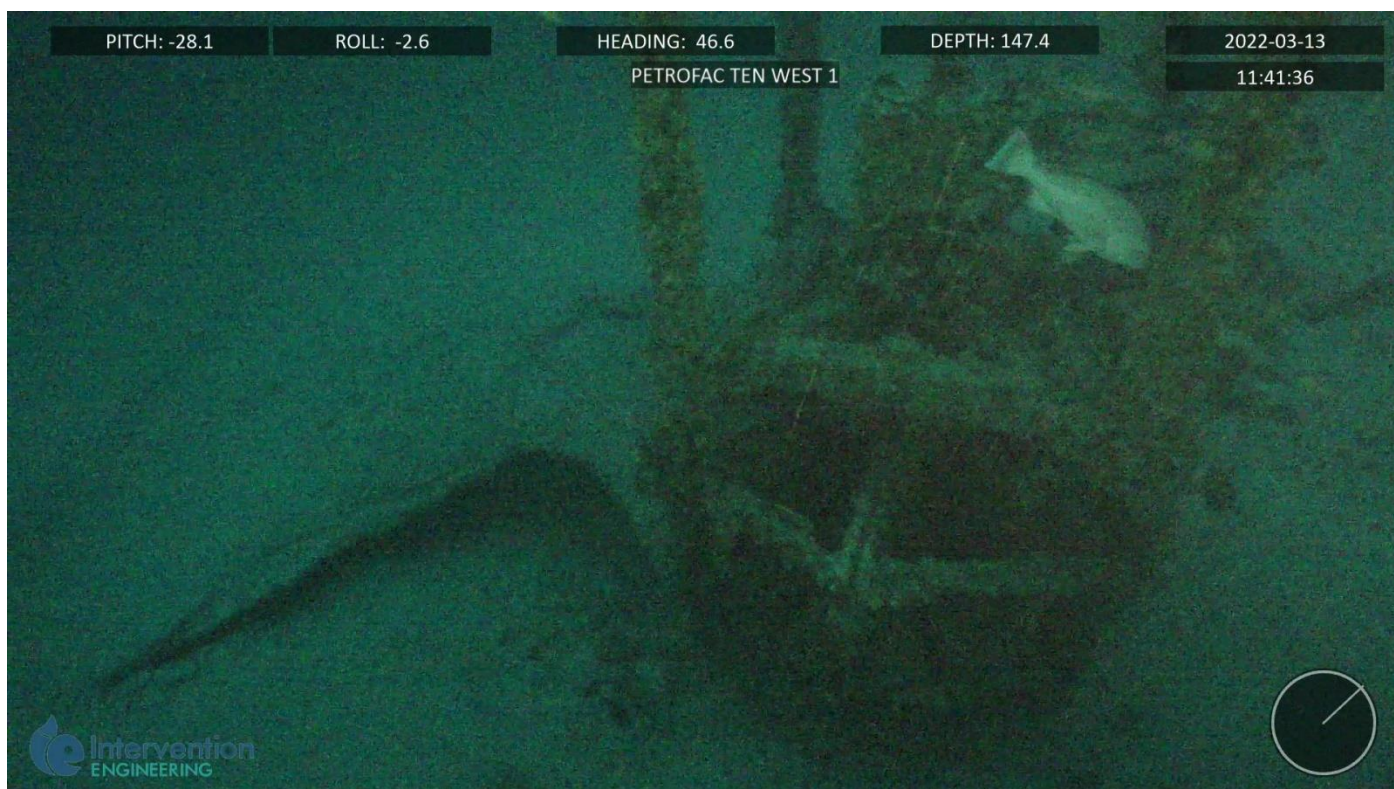
There is concrete / grout seen around the wellhead on the seabed. A majority of this is broken up into smaller pieces around the wellhead, with one section still intact making a small bridged section. (Figure 7 and 8)

**Figure 7** Ten West 1 example grout on seabed

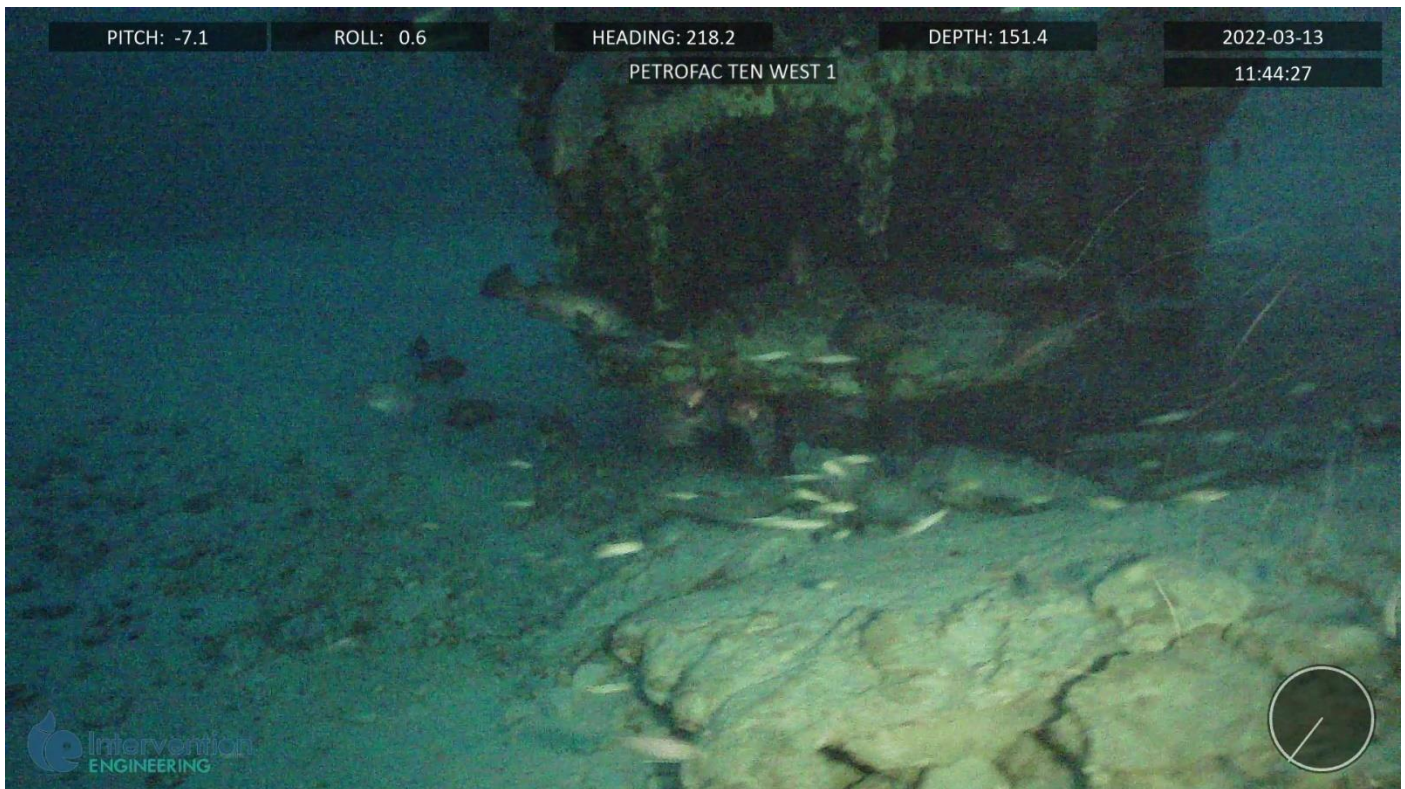
**Figure 8** Ten West 1 example broken grout on seabed

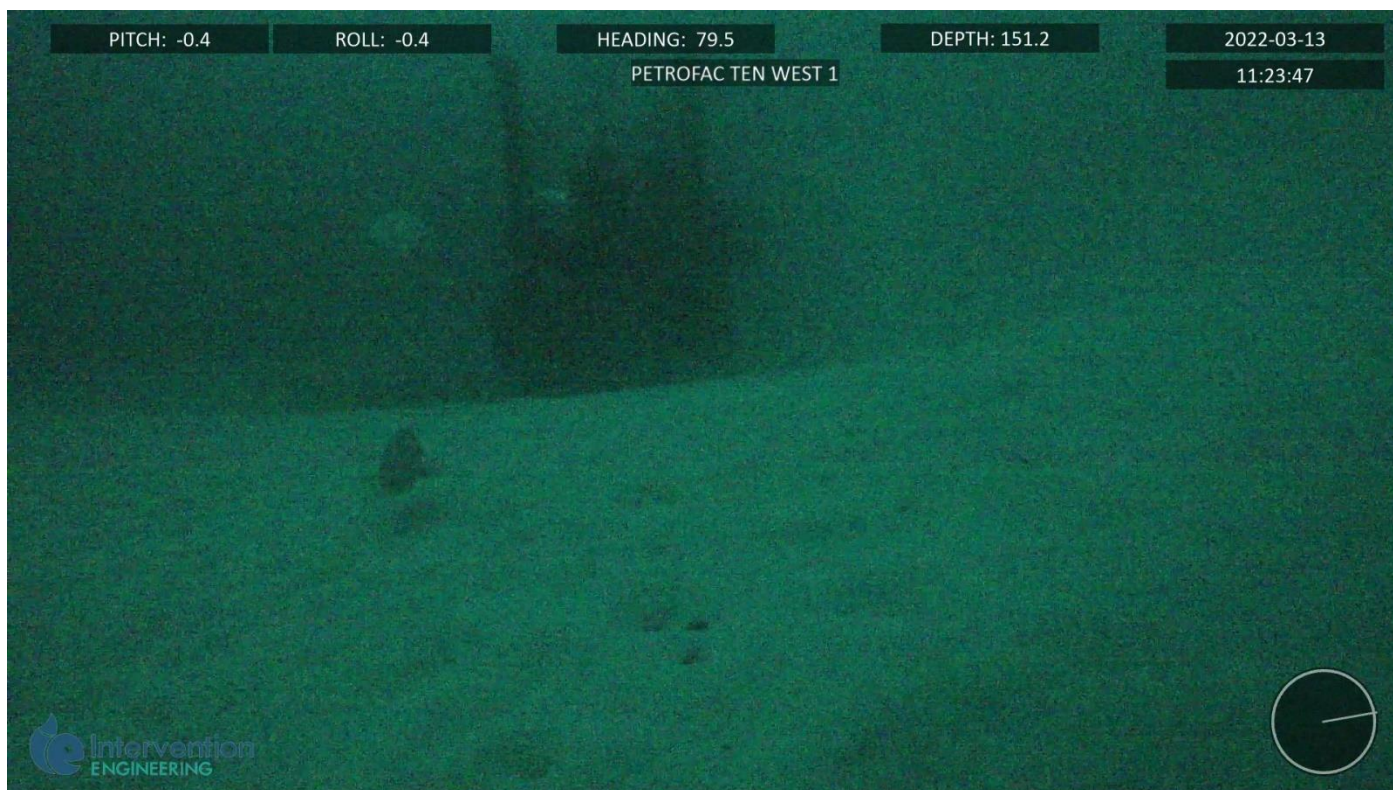
The Ten West 1 wellhead had created a depression in the seabed around it which is shown in Figure 9.

**Figure 9** Ten West 1 well head and surrounding seabed

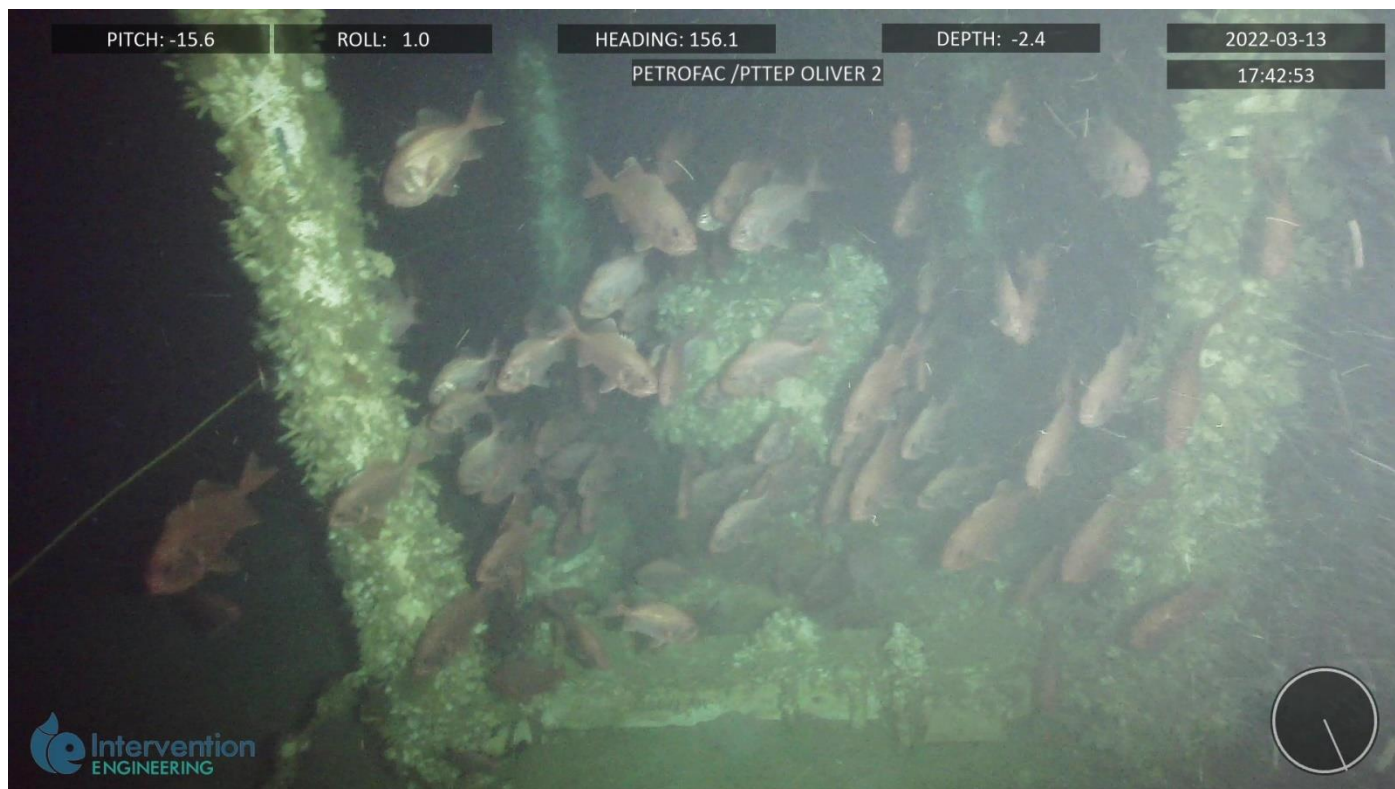
The wellhead has significant hard marine growth on all areas and was a haven for fish and other marine life in the area. (Figure 11)

**Figure 11** Oliver 2 marine life overview

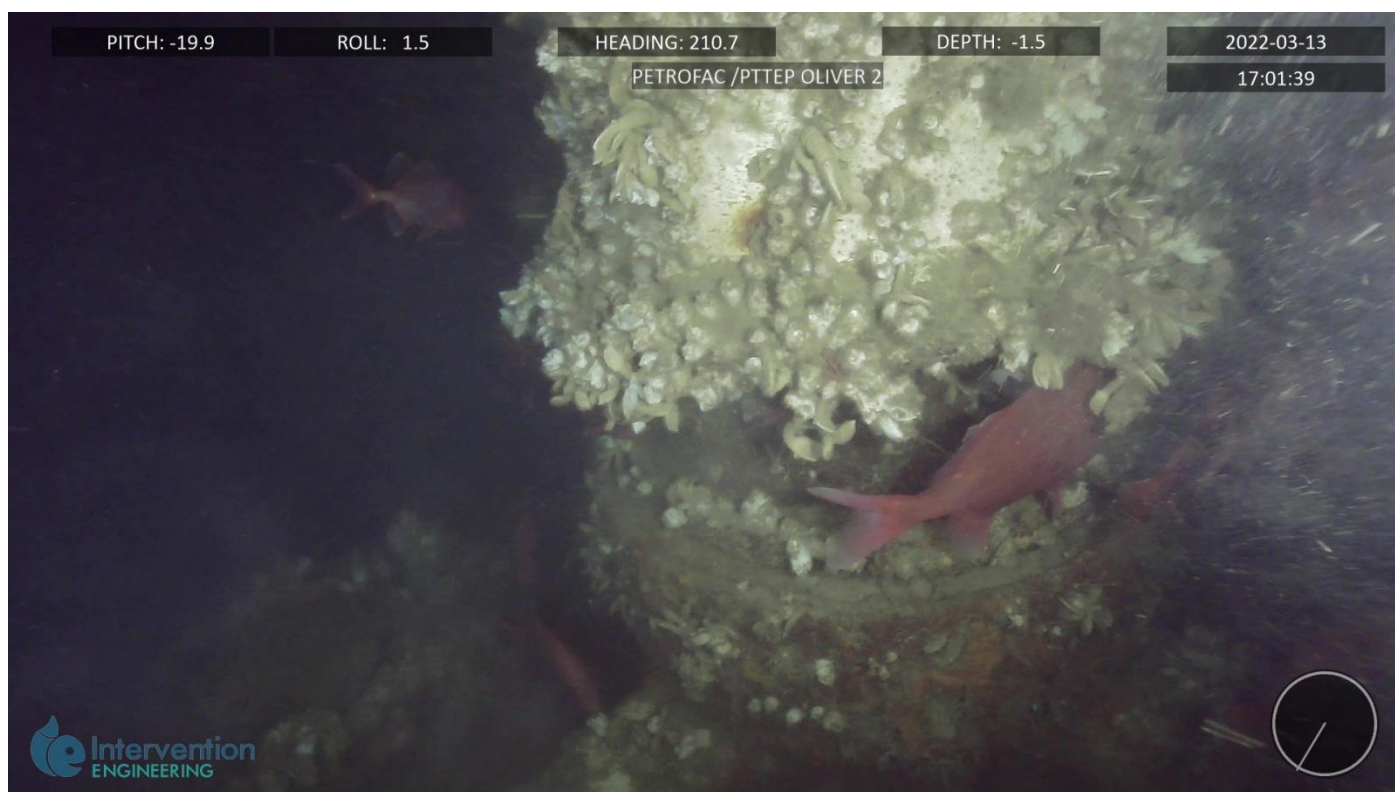
The wellhead had evident corrosion in all main unpainted areas (Figure 12). There were no anodes seen on the wellhead or guide base.

**Figure 12** Oliver 2 Example of corrosion on wellhead

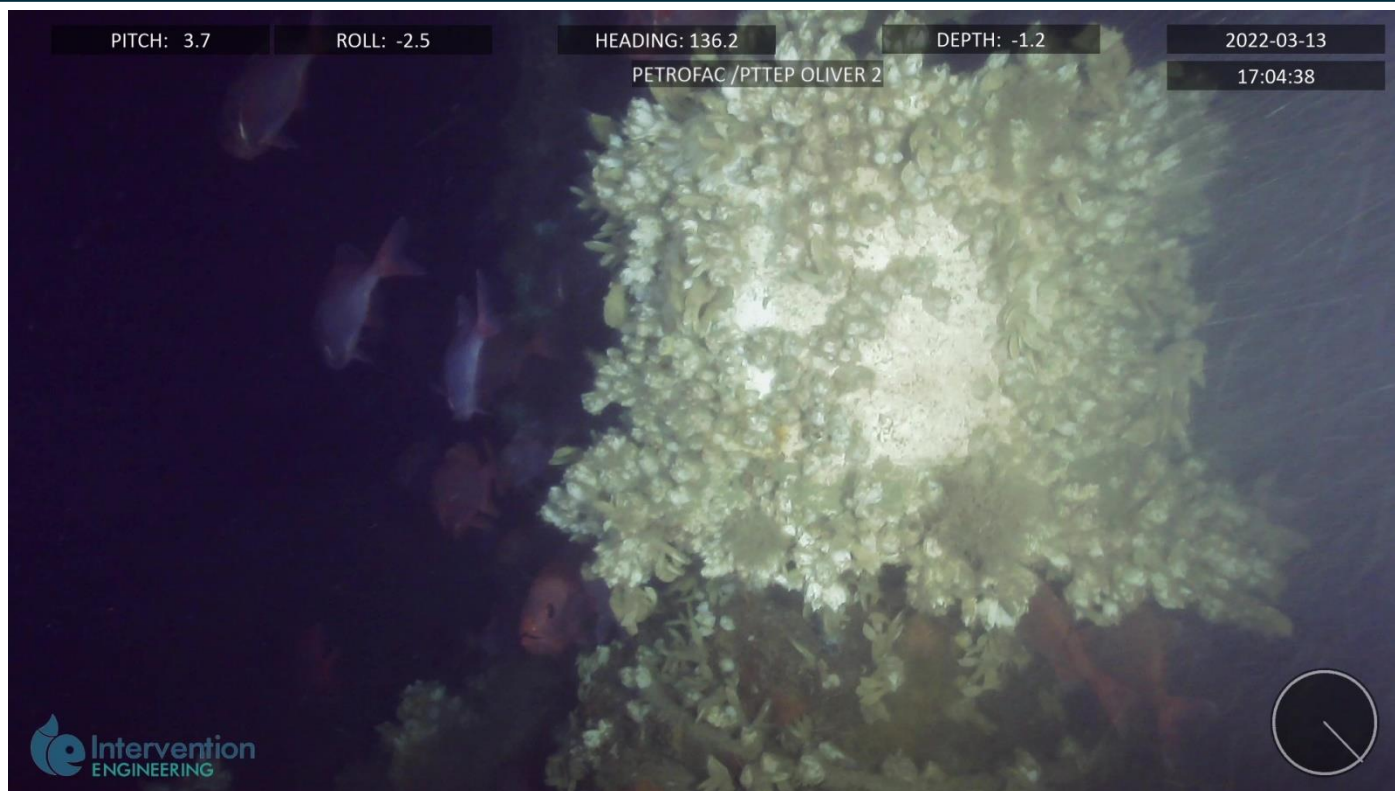
The corrosion cap was intact, in place and appeared undamaged. (Figure 13)

**Figure 13** Oliver 2 Corrosion cap

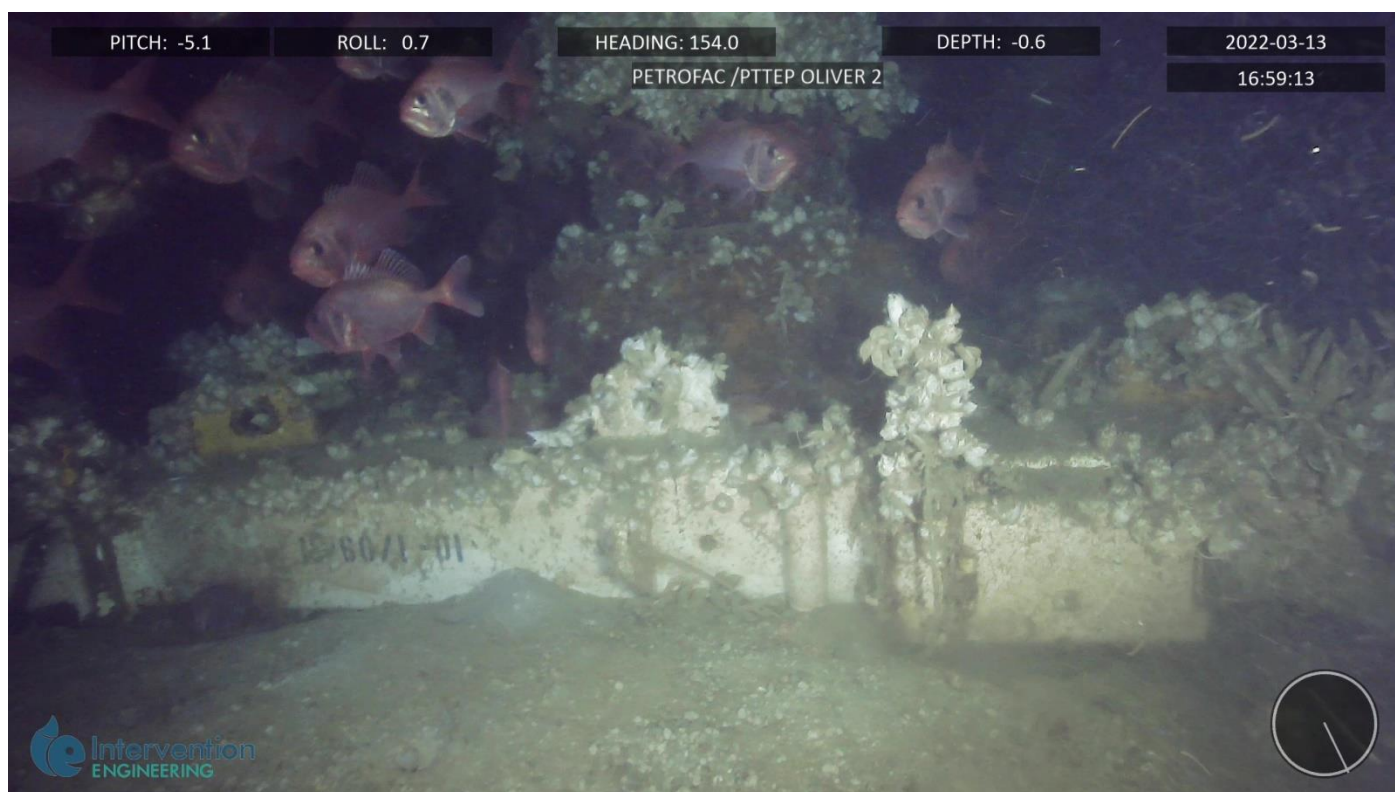
There is no significant scour seen under the guide base as the PGB appears to be level with the seabed in most areas. Areas that are not in contact with the seabed are only approx. 0.1m above seabed. (Figure 14)

**Figure 14** Oliver 2 PGB at seabed level

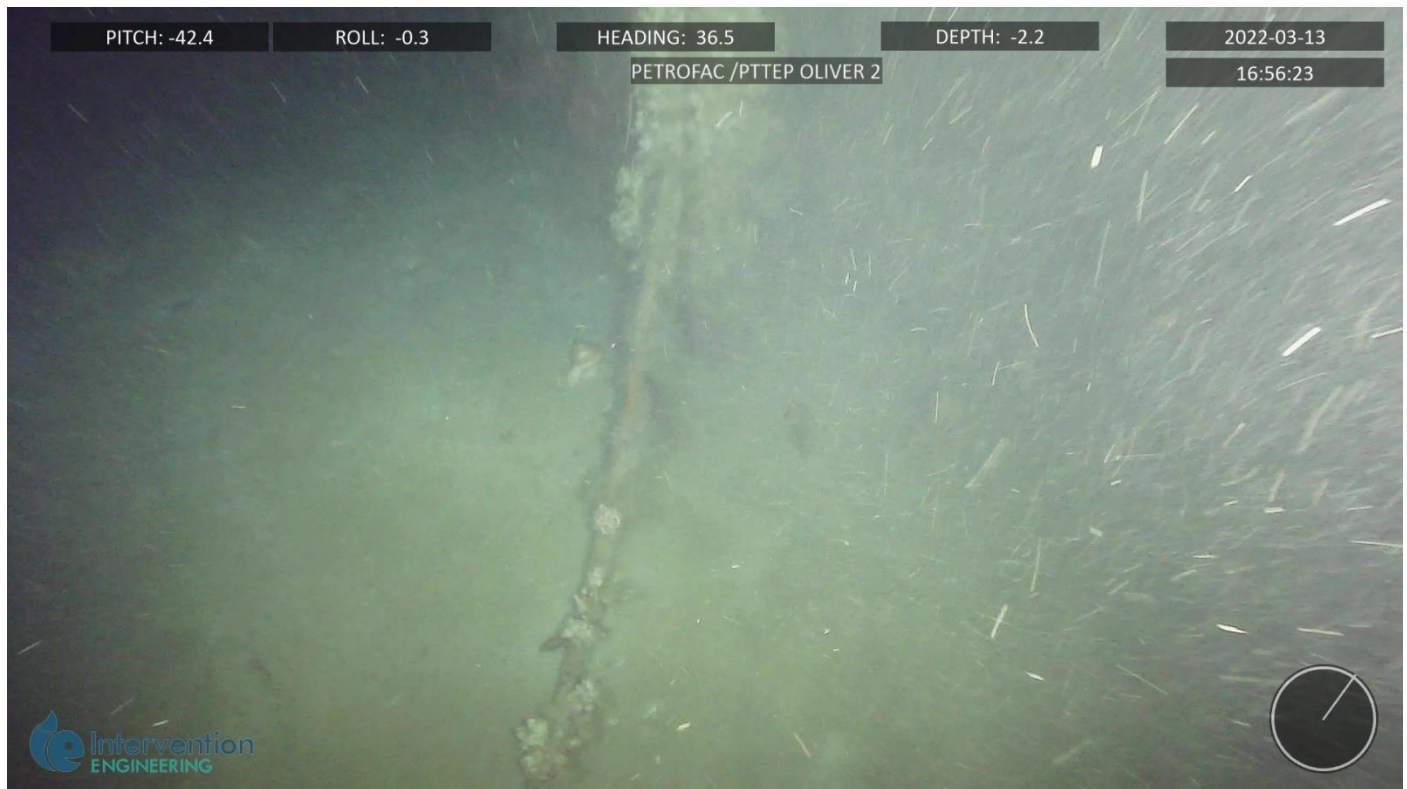
Each of the 4 guide posts have a remnant of guide wire hanging out of each post. The small section of guide wire has fallen out of the slit in the guide post and is in contact with the seabed. (Figure 15)

**Figure 15** Oliver 2 Guide wire remnant in contact with seabed

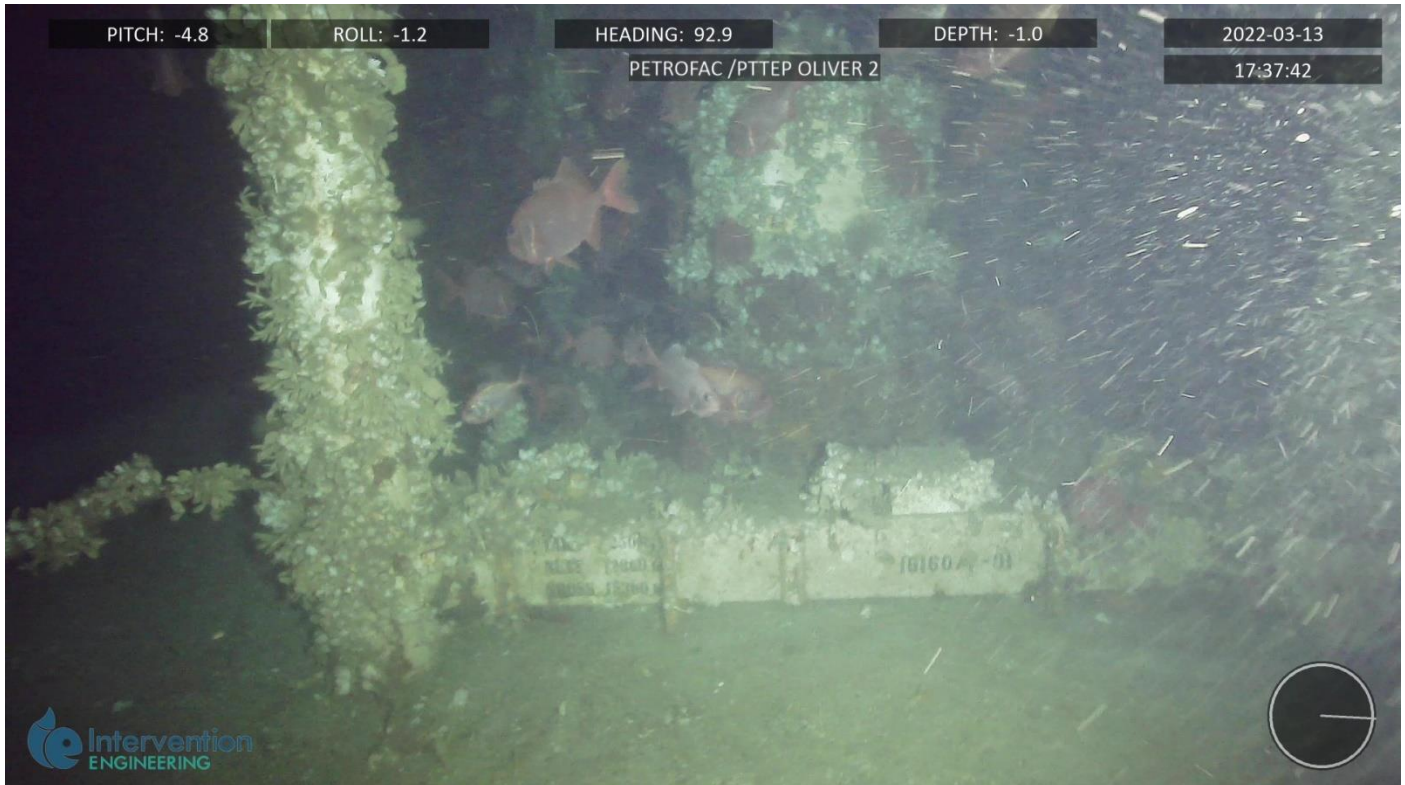
The Oliver 2 PGB is at seabed level, which is shown in Figure 16. There is a small rise in the seabed around the wellhead, which then goes back to mean seabed. This difference is very small. It is estimated at less than 0.2m (Figure 17)

**Figure 16** Oliver 2 PGB at seabed level

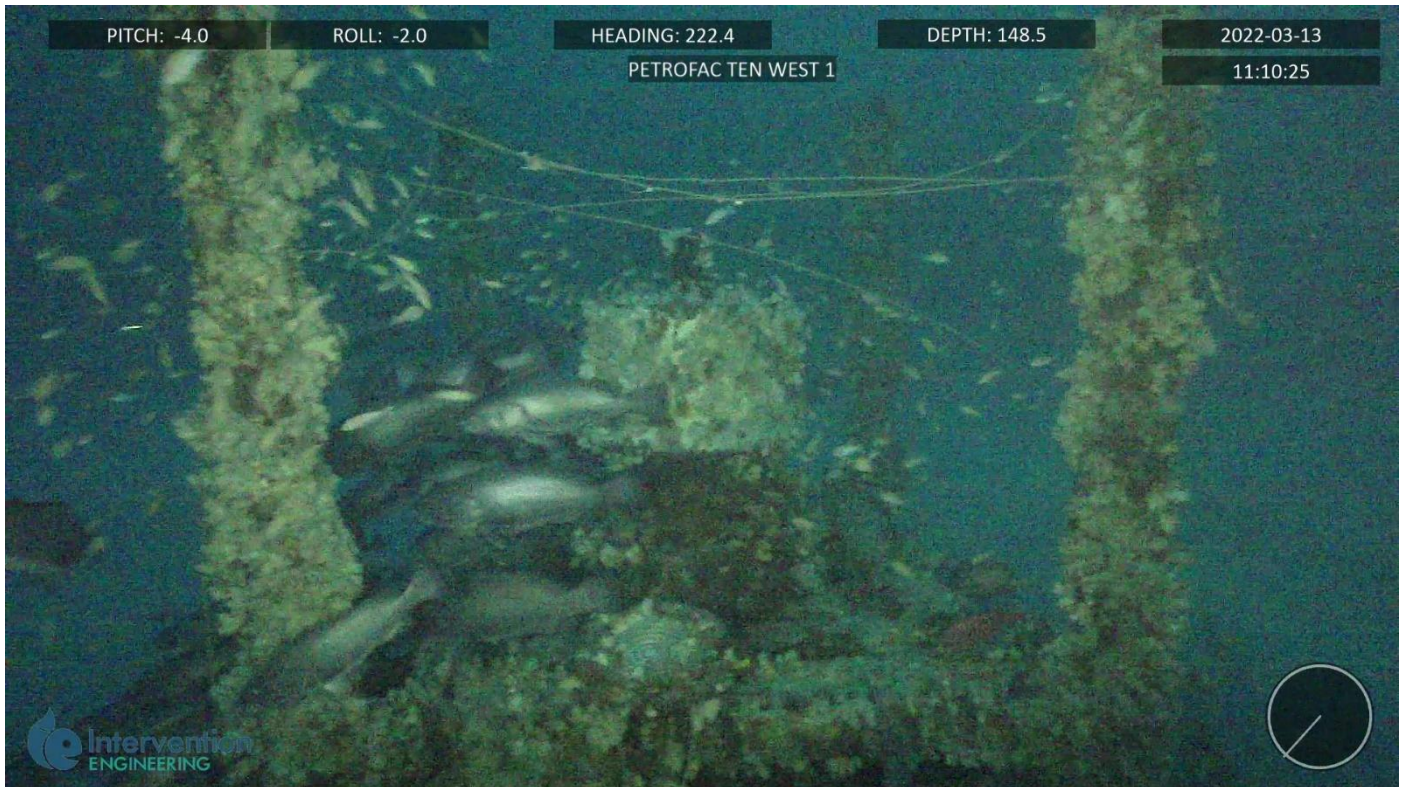
**Figure 19** Ten West 1 - Pic00021

Anomaly	Location	Description	Picture
Fishing line	Ten West 1	Light fishing line	Ten west 1 - Pic00021
Guide wire NE	Oliver 2	Cut Guide wire	Oliver 2 - Pic00019
Guide wire SW	Oliver 2	Cut Guide wire	Oliver 2 - Pic00020
Guide wire NW	Oliver 2	Cut Guide wire	Oliver 2 - Pic00021
Guide wire SE	Oliver 2	Cut Guide wire	Oliver 2 - Pic00022
