## Intervention Engineering

# Inspection of Ten West 1 and Oliver 2 wells

PTTEP / Petrofac

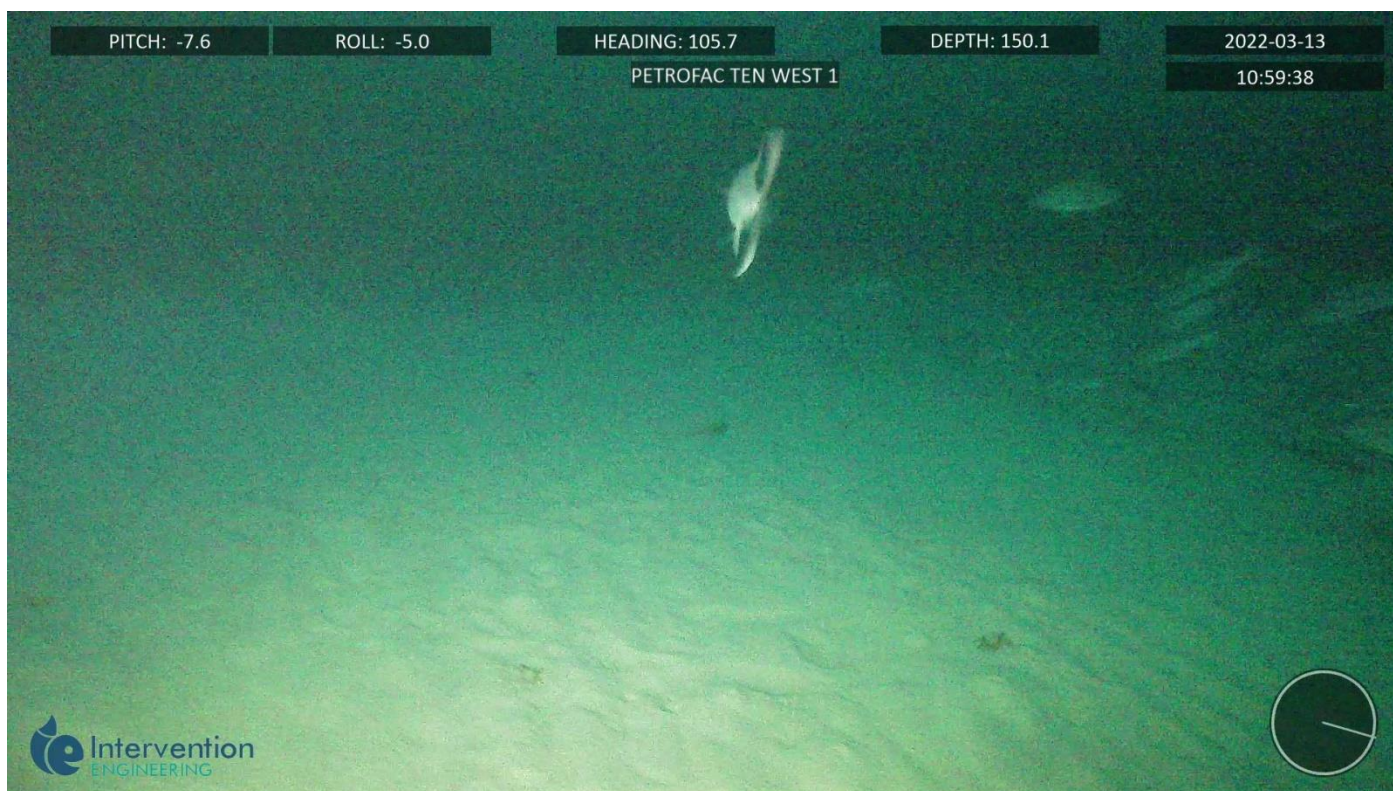
**Figure 10** Ten West 1 example surrounding seabed

An example of the seabed around the well is in Figure 10.

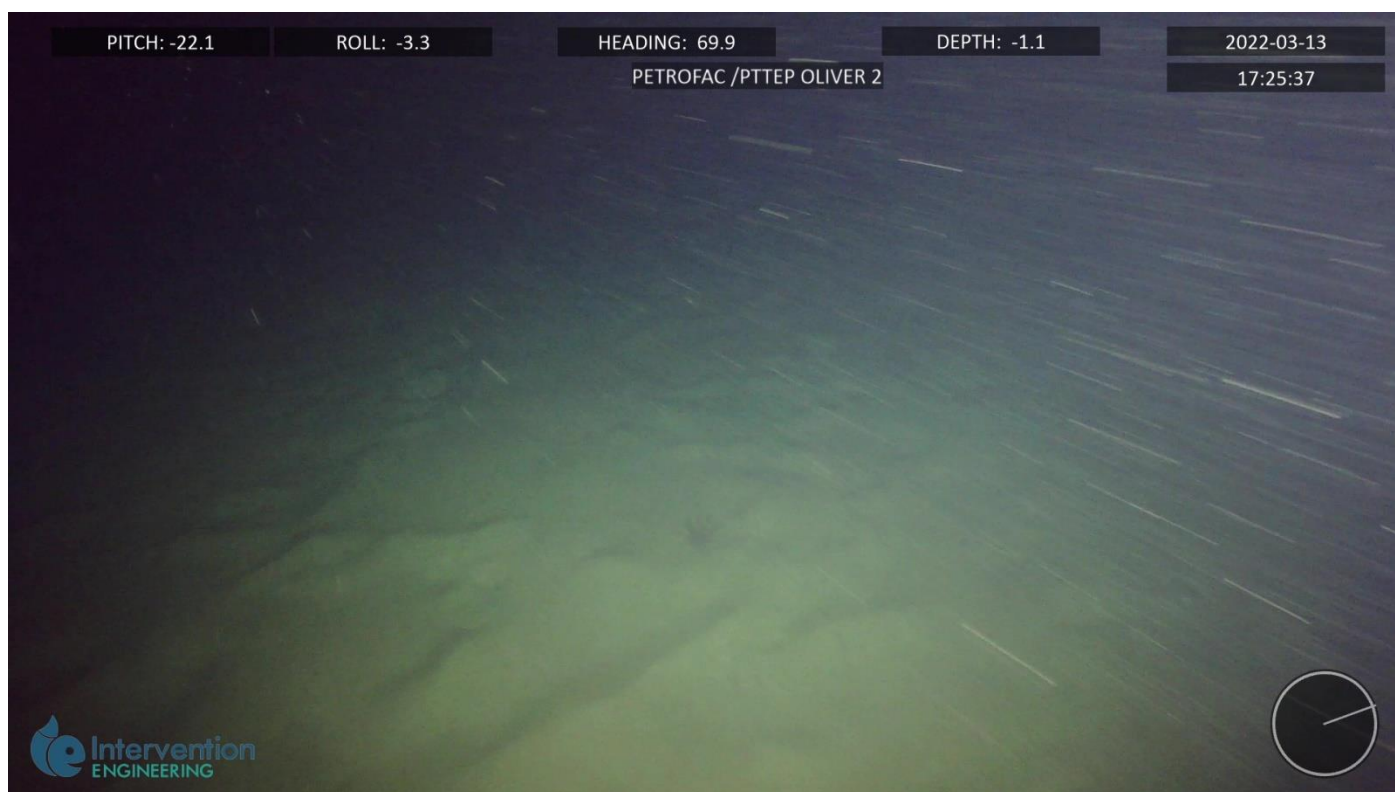
**Figure 18** Oliver 2 wellhead example of surrounding seabed

An example of the seabed around the well is in Figure 18.
